Name Of Dam: BIG CHERRY DAM

Location: WISE COUNTY, VIRGINIA

Inventory Number: VA 19502

PHASE I INSPECTION REPORT NATIONAL DAM SAFETY PROGRAM

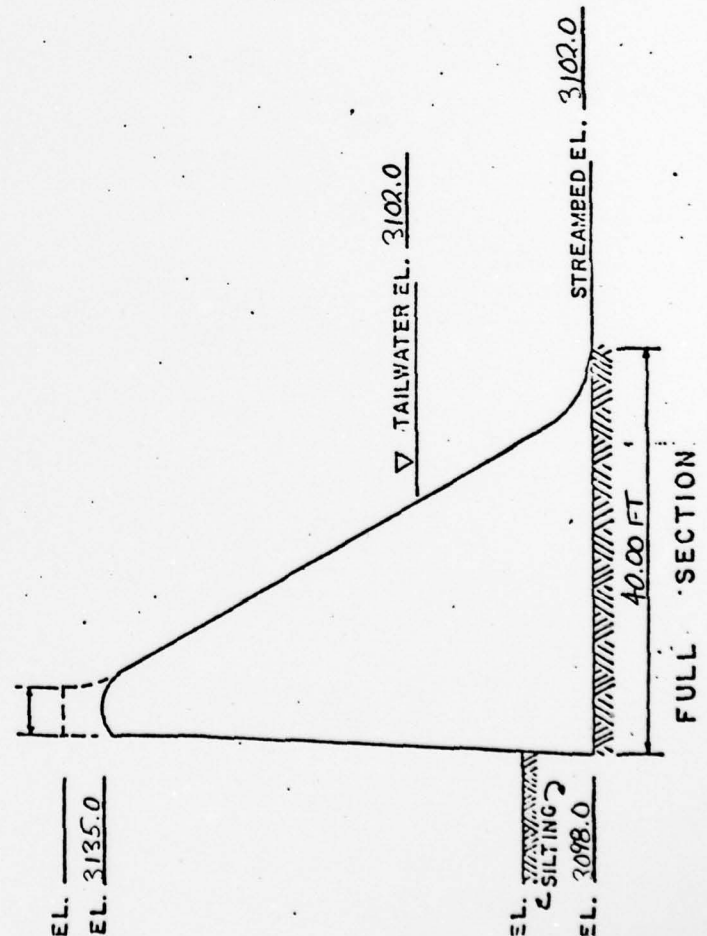
LOADING CASE	ELEV. HEAD WATER	ELEV. TAIL WATER	ΣV	ΣH	$\frac{\Sigma H}{\Sigma V}$	LOCATION RESULTANT FROM TOE	% BASE IN COMPRESSION	FACTOR SAFETY SLIDING	FOUNDATION PRESSURE	
									TOE	HEEL
PMF	3145.1	3102.0	63.0 K/FT	66.1 K/FT	1.05	11.49 FT	86%	0.54	3.66 KSF	0.0 KSF
$\frac{1}{2}$ PMF	3142.1	3102.0	66.8	59.1	0.88	14.27	100%	0.67	3.11	0.23
NORMAL WATER LEVEL + ICE	3135.0	3102.0	75.6	47.7	0.63	17.31	100%	1.04	2.65	1.13

NOTES: ANALYSIS PERFORMED ON 1 FT. THICK SECTION WITH FULL UPLIFT
 FOR SLIDING ALONG POTENTIAL FAILURE PLANE,
 $\phi = 32^\circ$
 $\delta = 0$
